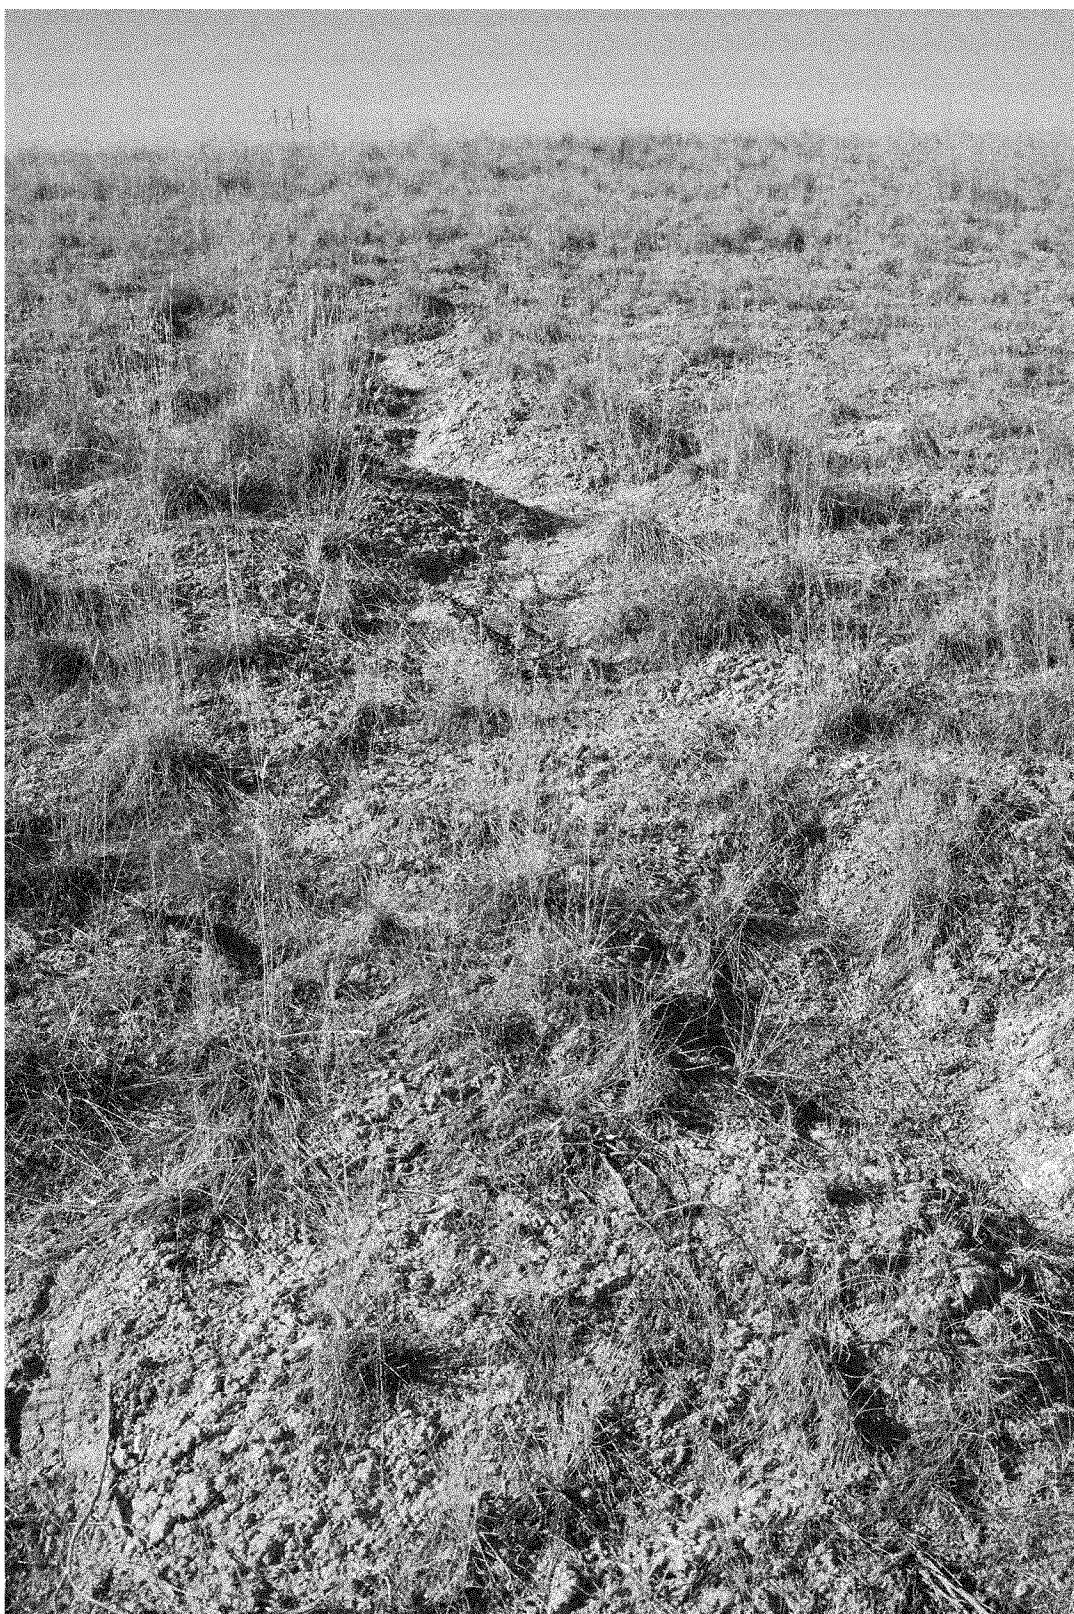
Figure B-12. Erosion rill along north slope of CFA-02 Landfill II (PD020605-12).

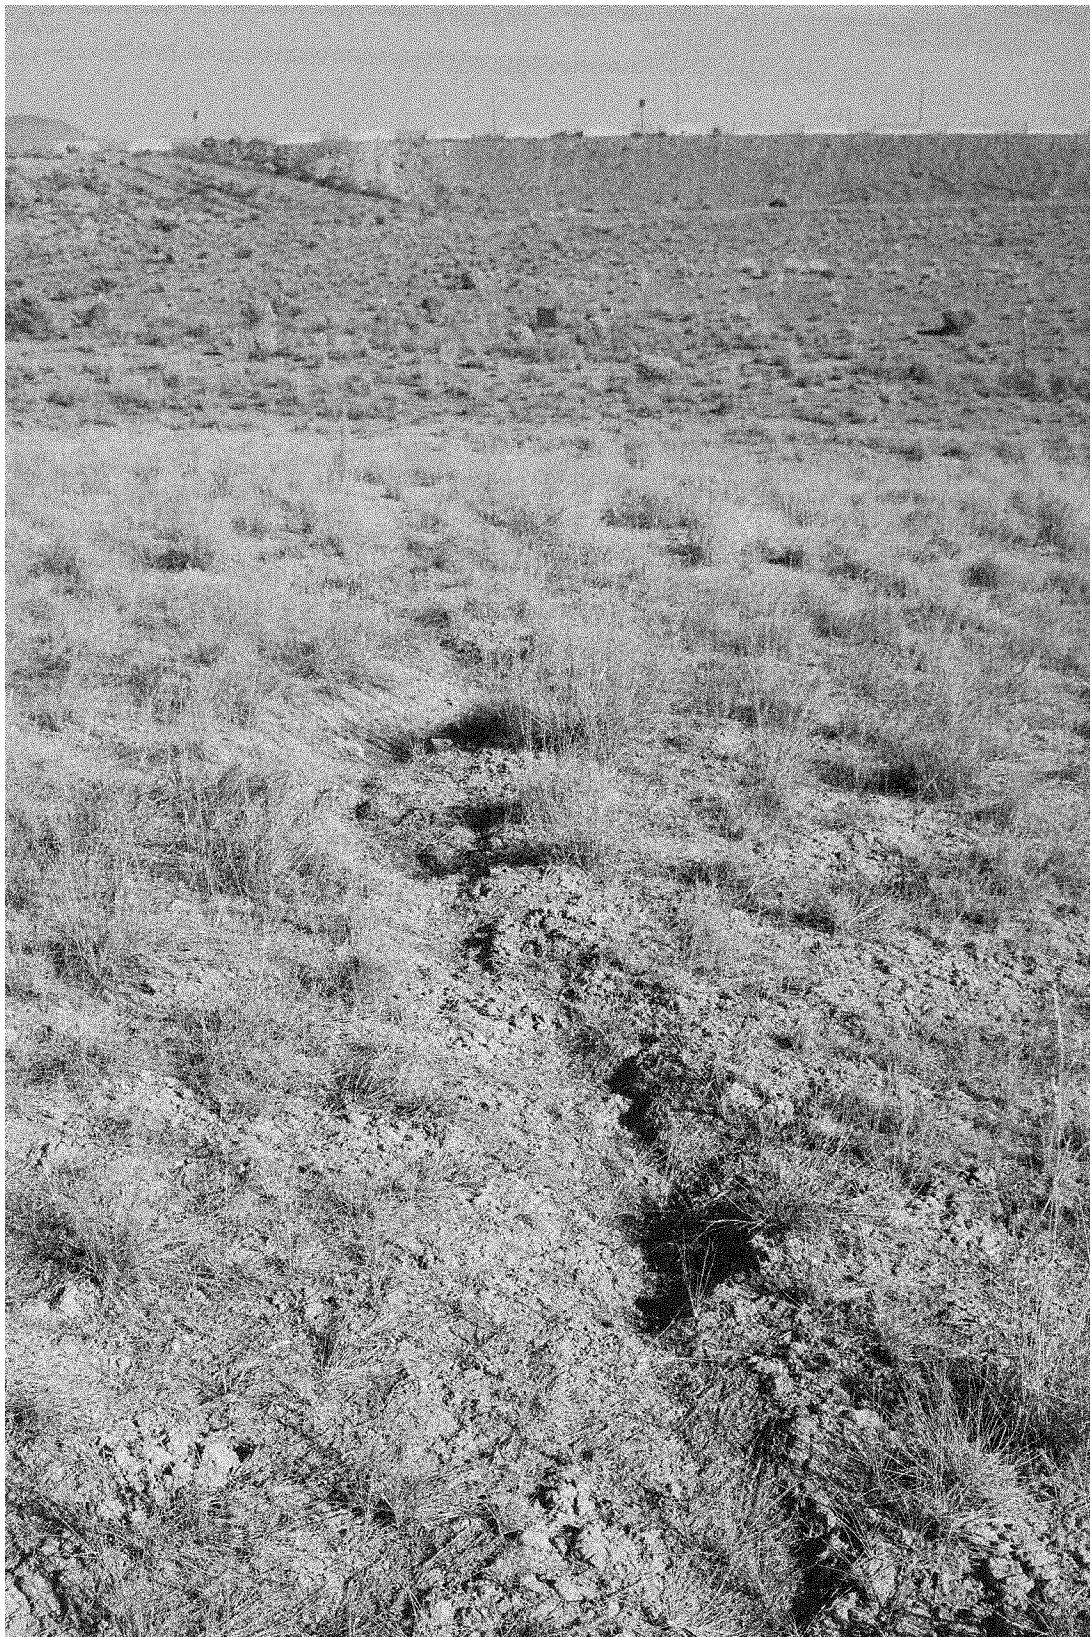
Figure B-13. Erosion rill on north slope of CFA-02 Landfill II (PD020605-13).

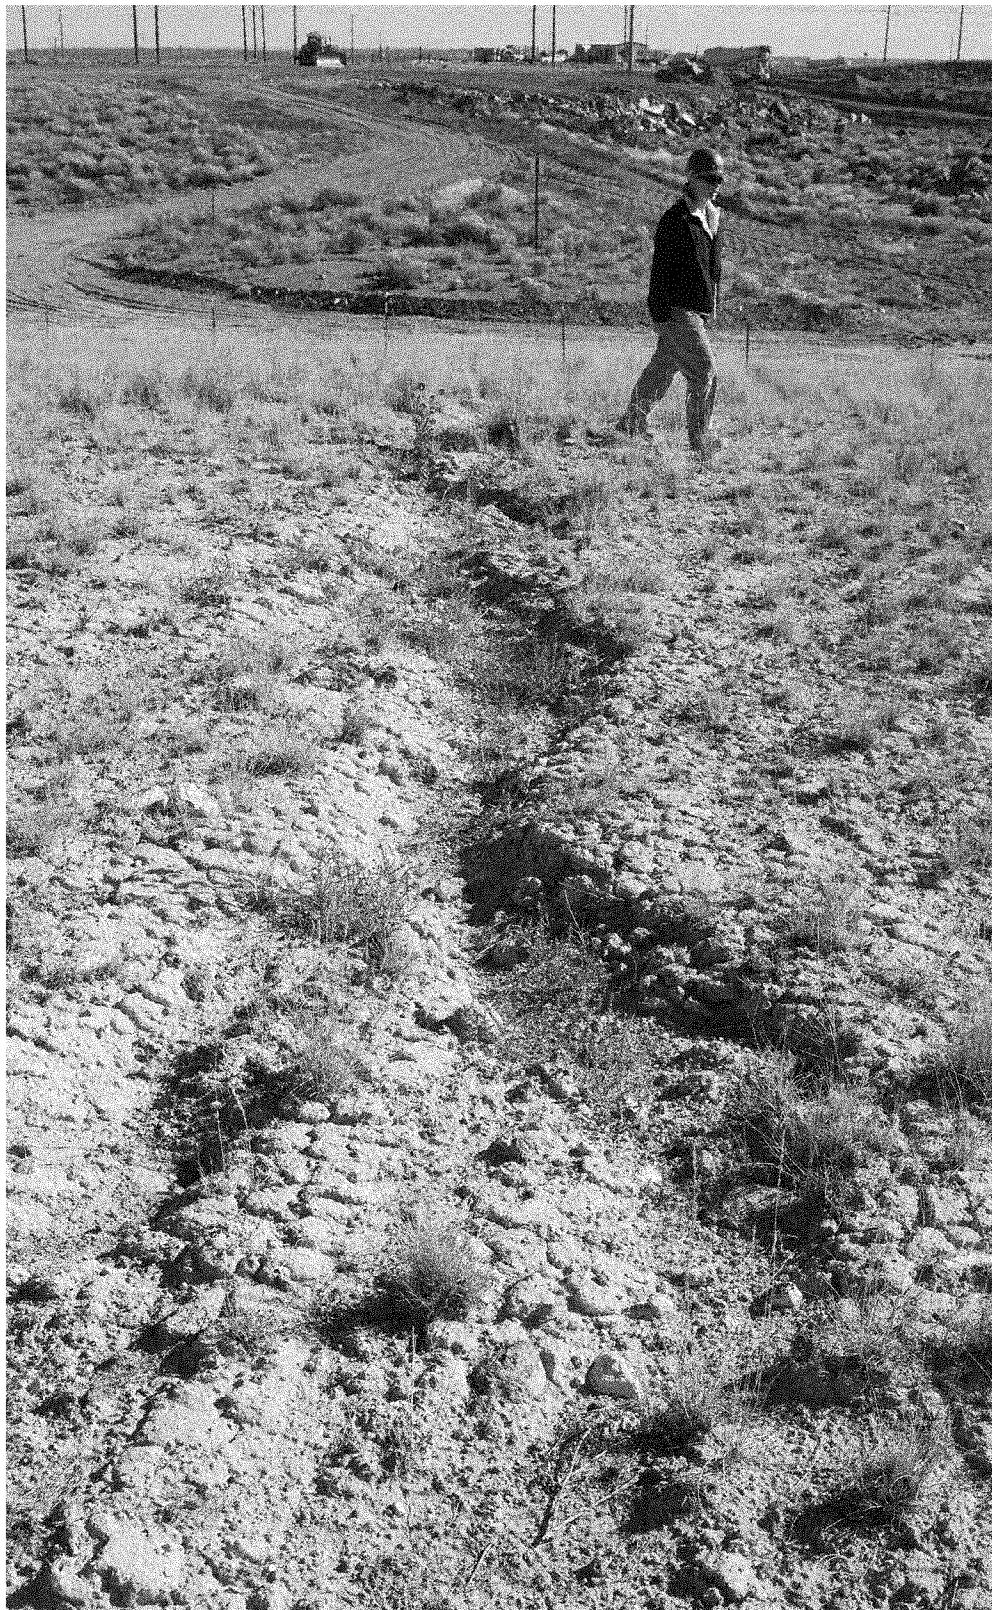
Figure B-14. Erosion rill on northeast slope of CFA-02 Landfill II.

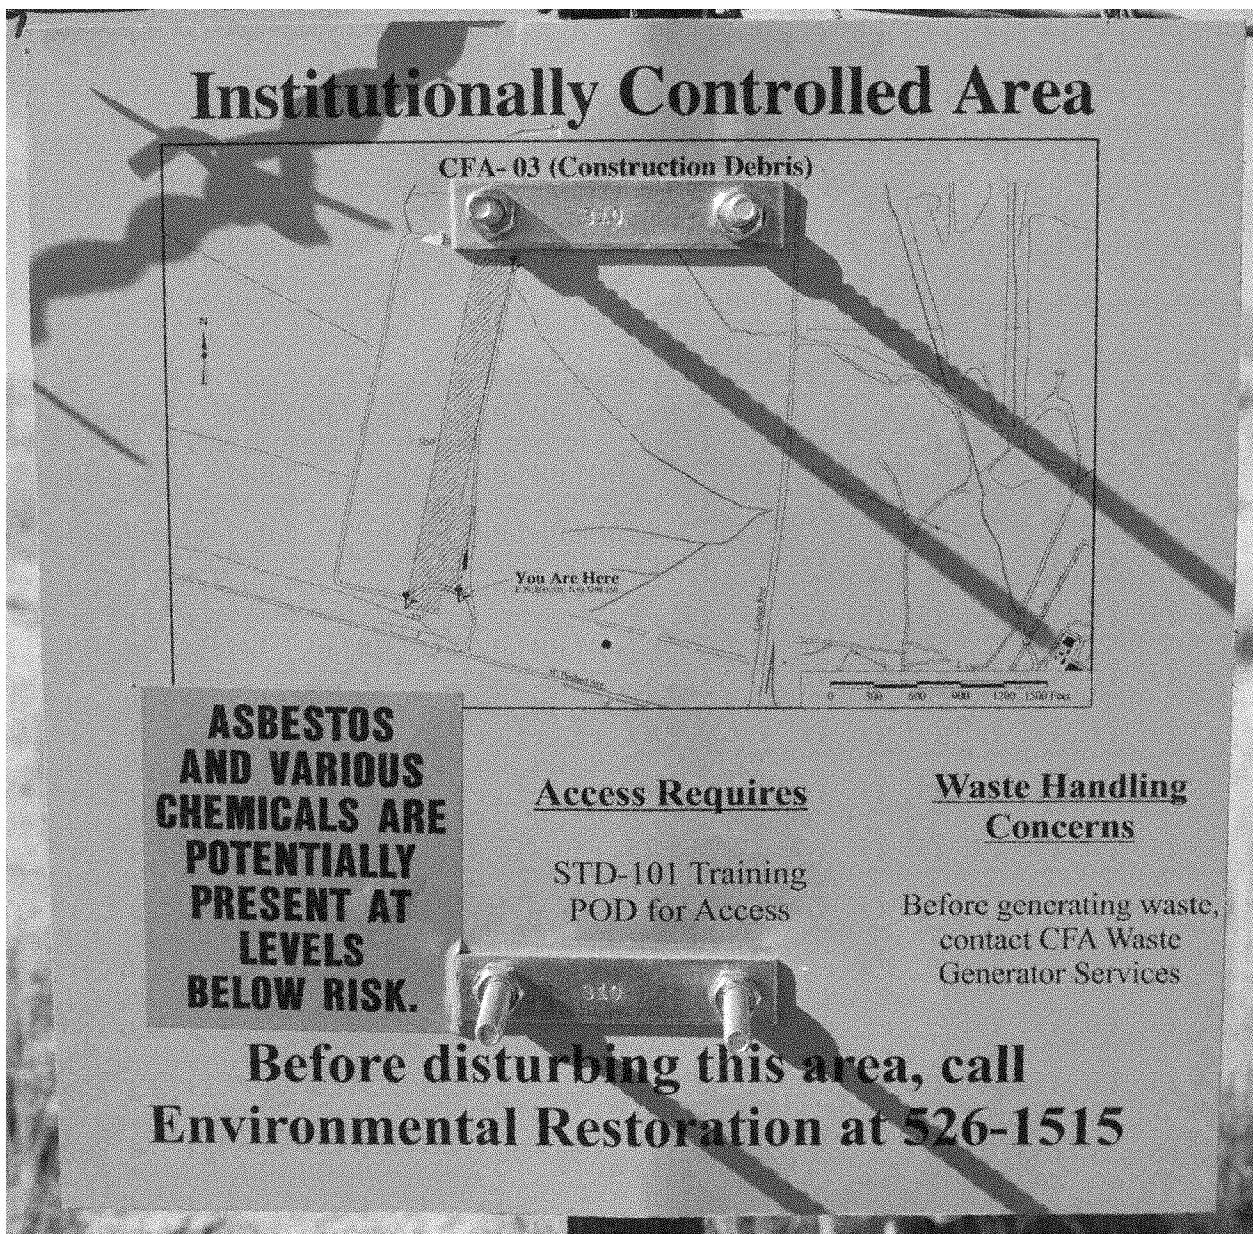
Figure B-15. Institutional control sign at CFA-03 Landfill III (PD020605-23).
